# Sample Inspection Report

Prepared For:  
John and Mary Doe  
3-9-2005

Property Address:  
1234 Any Street  
Cool Town, CO 12345

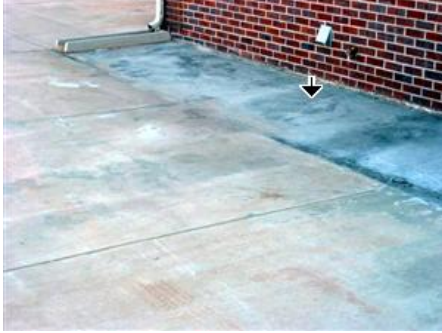
2.14 Picture 1

2.14 Spalling noted in several locations on driveway, particularly where the slab has sunk next to the house on the NE side. The depression near the home can cause water to pool and this should be repaired by a qualified contractor.

Spalling noted in several locations on driveway, particularly where the slab has sunk next to the house on the NE side. The depression near the home can cause water to pool and this should be repaired by a qualified contractor.

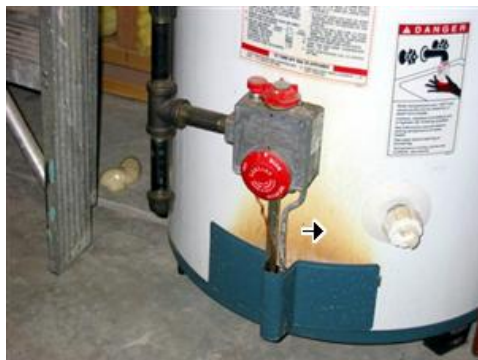
10.4 Picture 1

10.4 Hot water tank is 10 years old and showing signs of age. While working at the time of inspection, it is nearing the end of its life-expectancy.

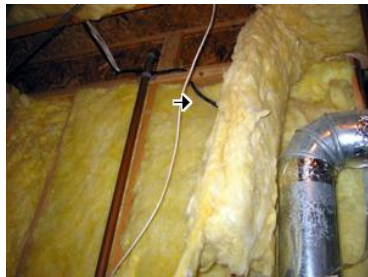
11.3 Picture 1

**11.3** Insulation has fallen from the ceiling joist in the furnace room. This should be repaired.

Insulation has fallen from the ceiling joist in the furnace room. This should be repaired.

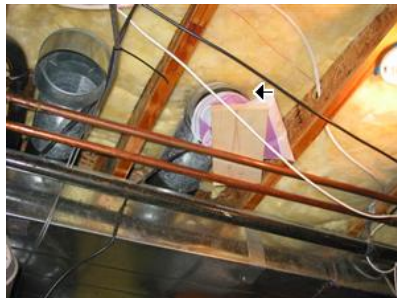
11.4 Picture 1

**11.4** One of the combustible air vents is plugged in the furnace room. The plug should be removed. Also, Douglas County requires both "high" and "low" combustible air vents. One of the two present should be extended to serve as the "low" vent.

One of the combustible air vents is plugged in the furnace room. The plug should be removed. Also, this county requires both "high" and "low" combustible air vents. One of the two present should be extended to serve as the "low" vent.
